# AERIAL PHOTOGRAPHIC ANALYSIS OF THE ALLIED CHEMICAL CORPORATION Danville, Illinois

TS-AMD-86615-2  
June 1987

R. W. Helmstadt  
Environmental Programs  
Lockheed Engineering and Management Services Company, Inc.  
Las Vegas, Nevada 89193-3478

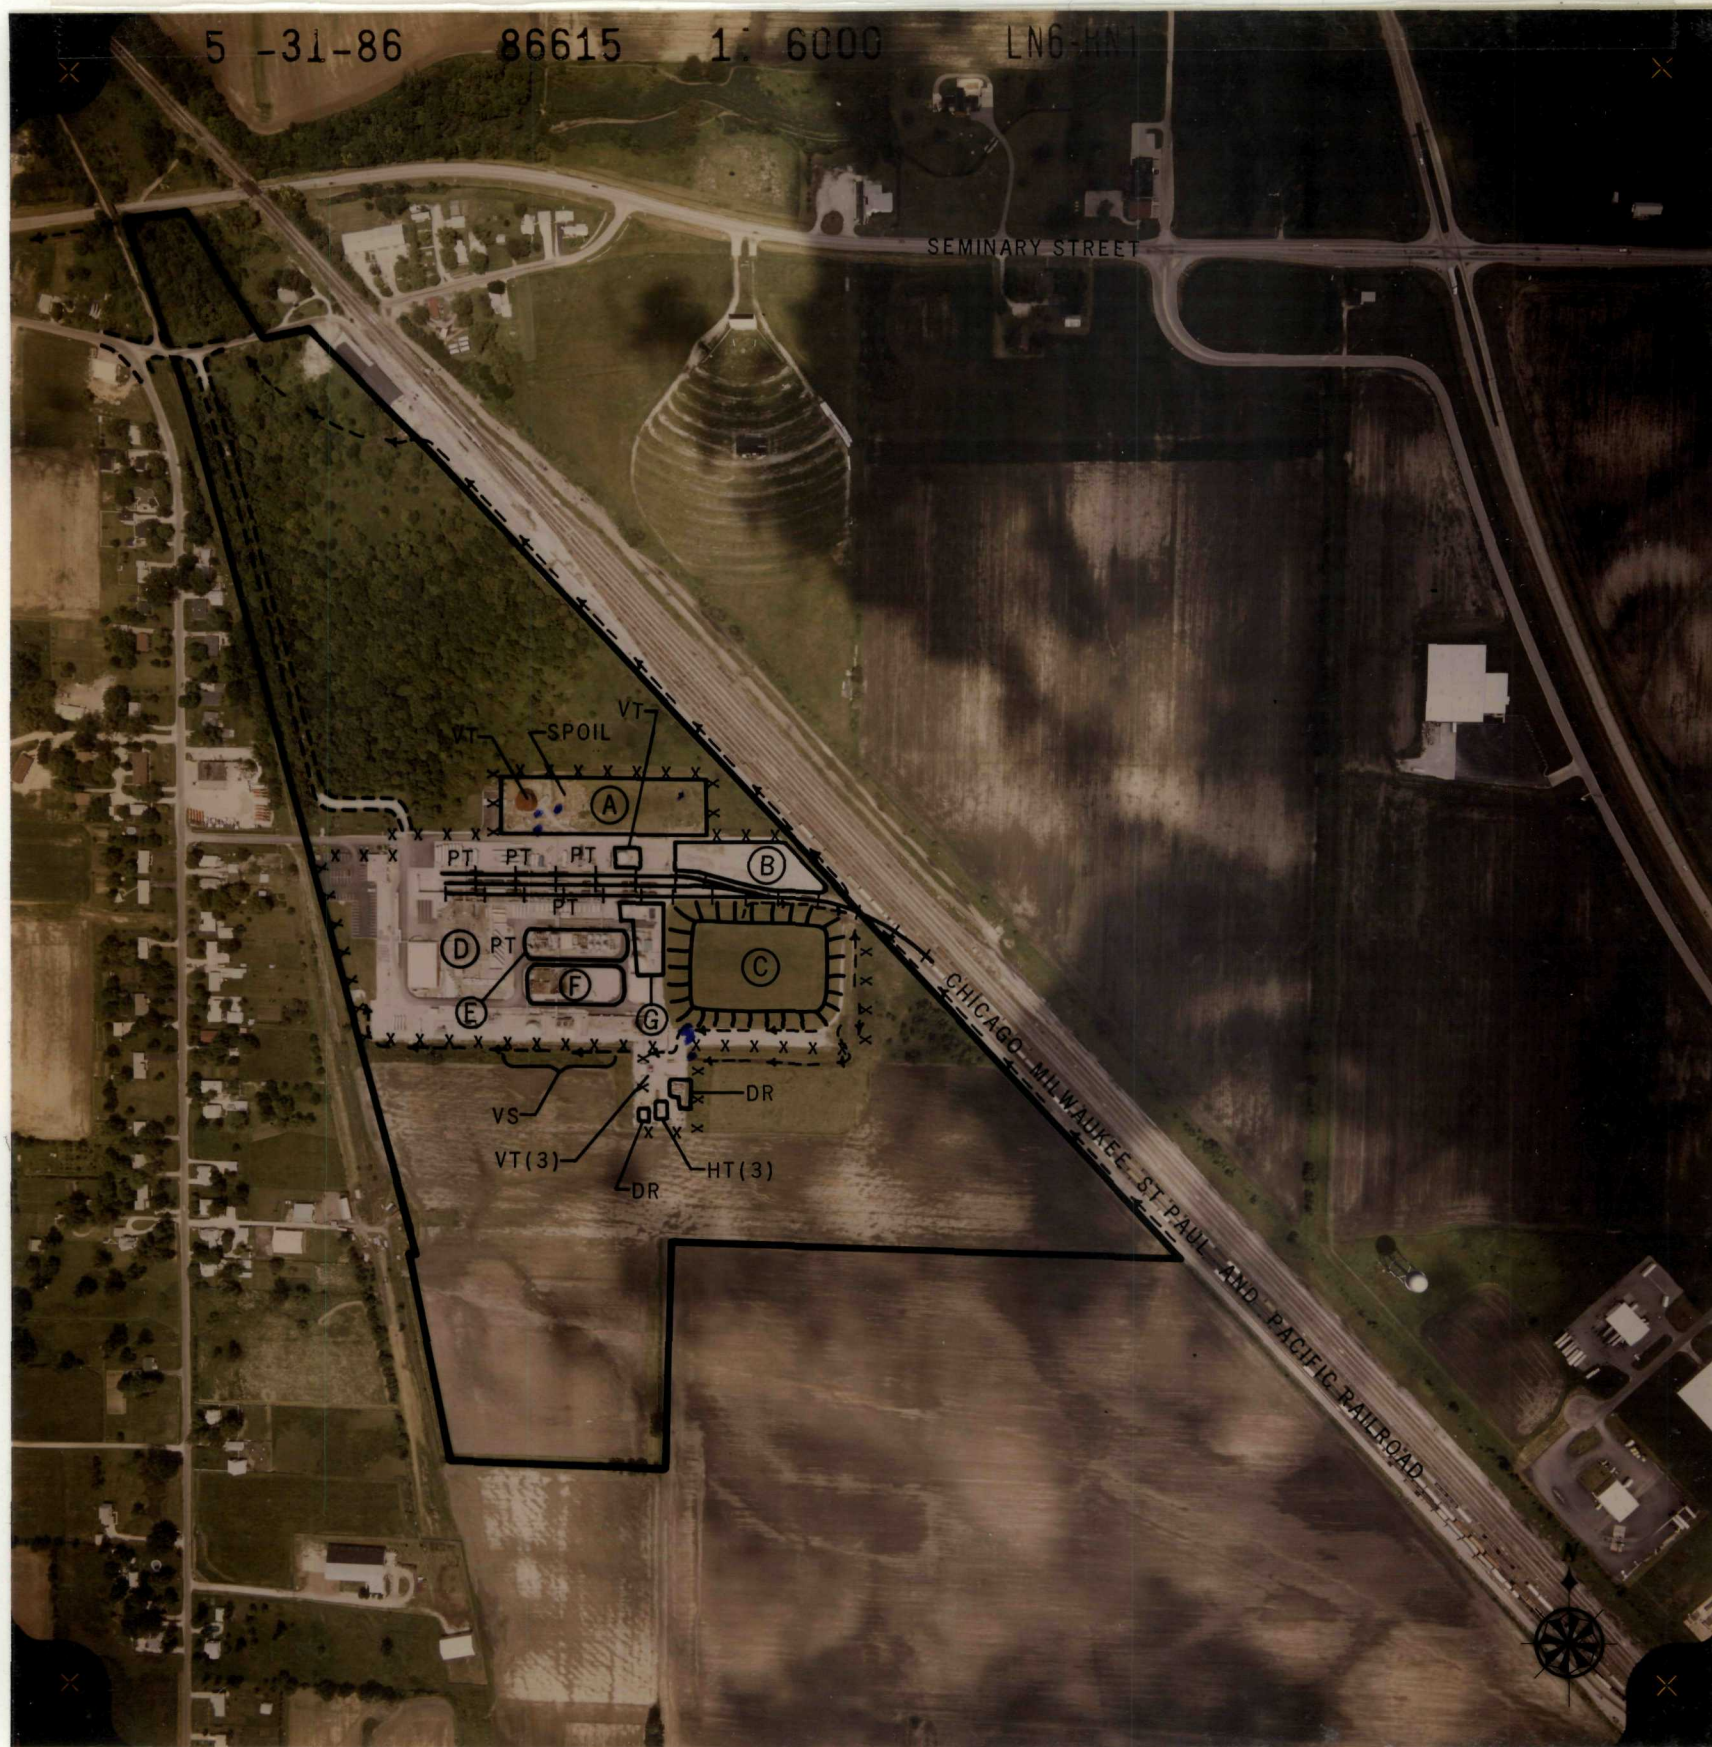
Figure 3. Allied Chemical Corporation, May 31, 1986. Approximate scale 1:6,000.

The Allied Chemical Corporation is a chemical manufacturing plant located in eastern Danville, Illinois (Figure 3). The most significant features identified on the photos include:

<u>Annotation</u>	<u>Description</u>
A - Waste pond (closed)	This revegetated waste pond contains a rusty vertical storage tank, and spoil.
B - Waste pond (closed)	This pond appears to have been recently covered and leveled.
C - Waste pond (closed)	This pond has been filled, covered, and revegetated.
D - Shipping/receiving	Crates, drums, and pressure tanks are present.
E - Storage/processing area	This area contains 13 storage/processing tanks and two possible processing units.
F - Probable laboratory	Single-story building.
G - Waste disposal area	This area contains one small effluent sump and four probable waste storage tanks.

An open storage area in the southern portion of the plant contains three horizontal tanks, four vertical tanks, and numerous drums. No secondary containment is visible. Surface runoff would enter one of the site's drainage ditches. Signs of oil, possible chemicals, and vegetation stress are visible inside these drainage ditches. These ditches lead into an unnamed creek that empties into Lick Creek.

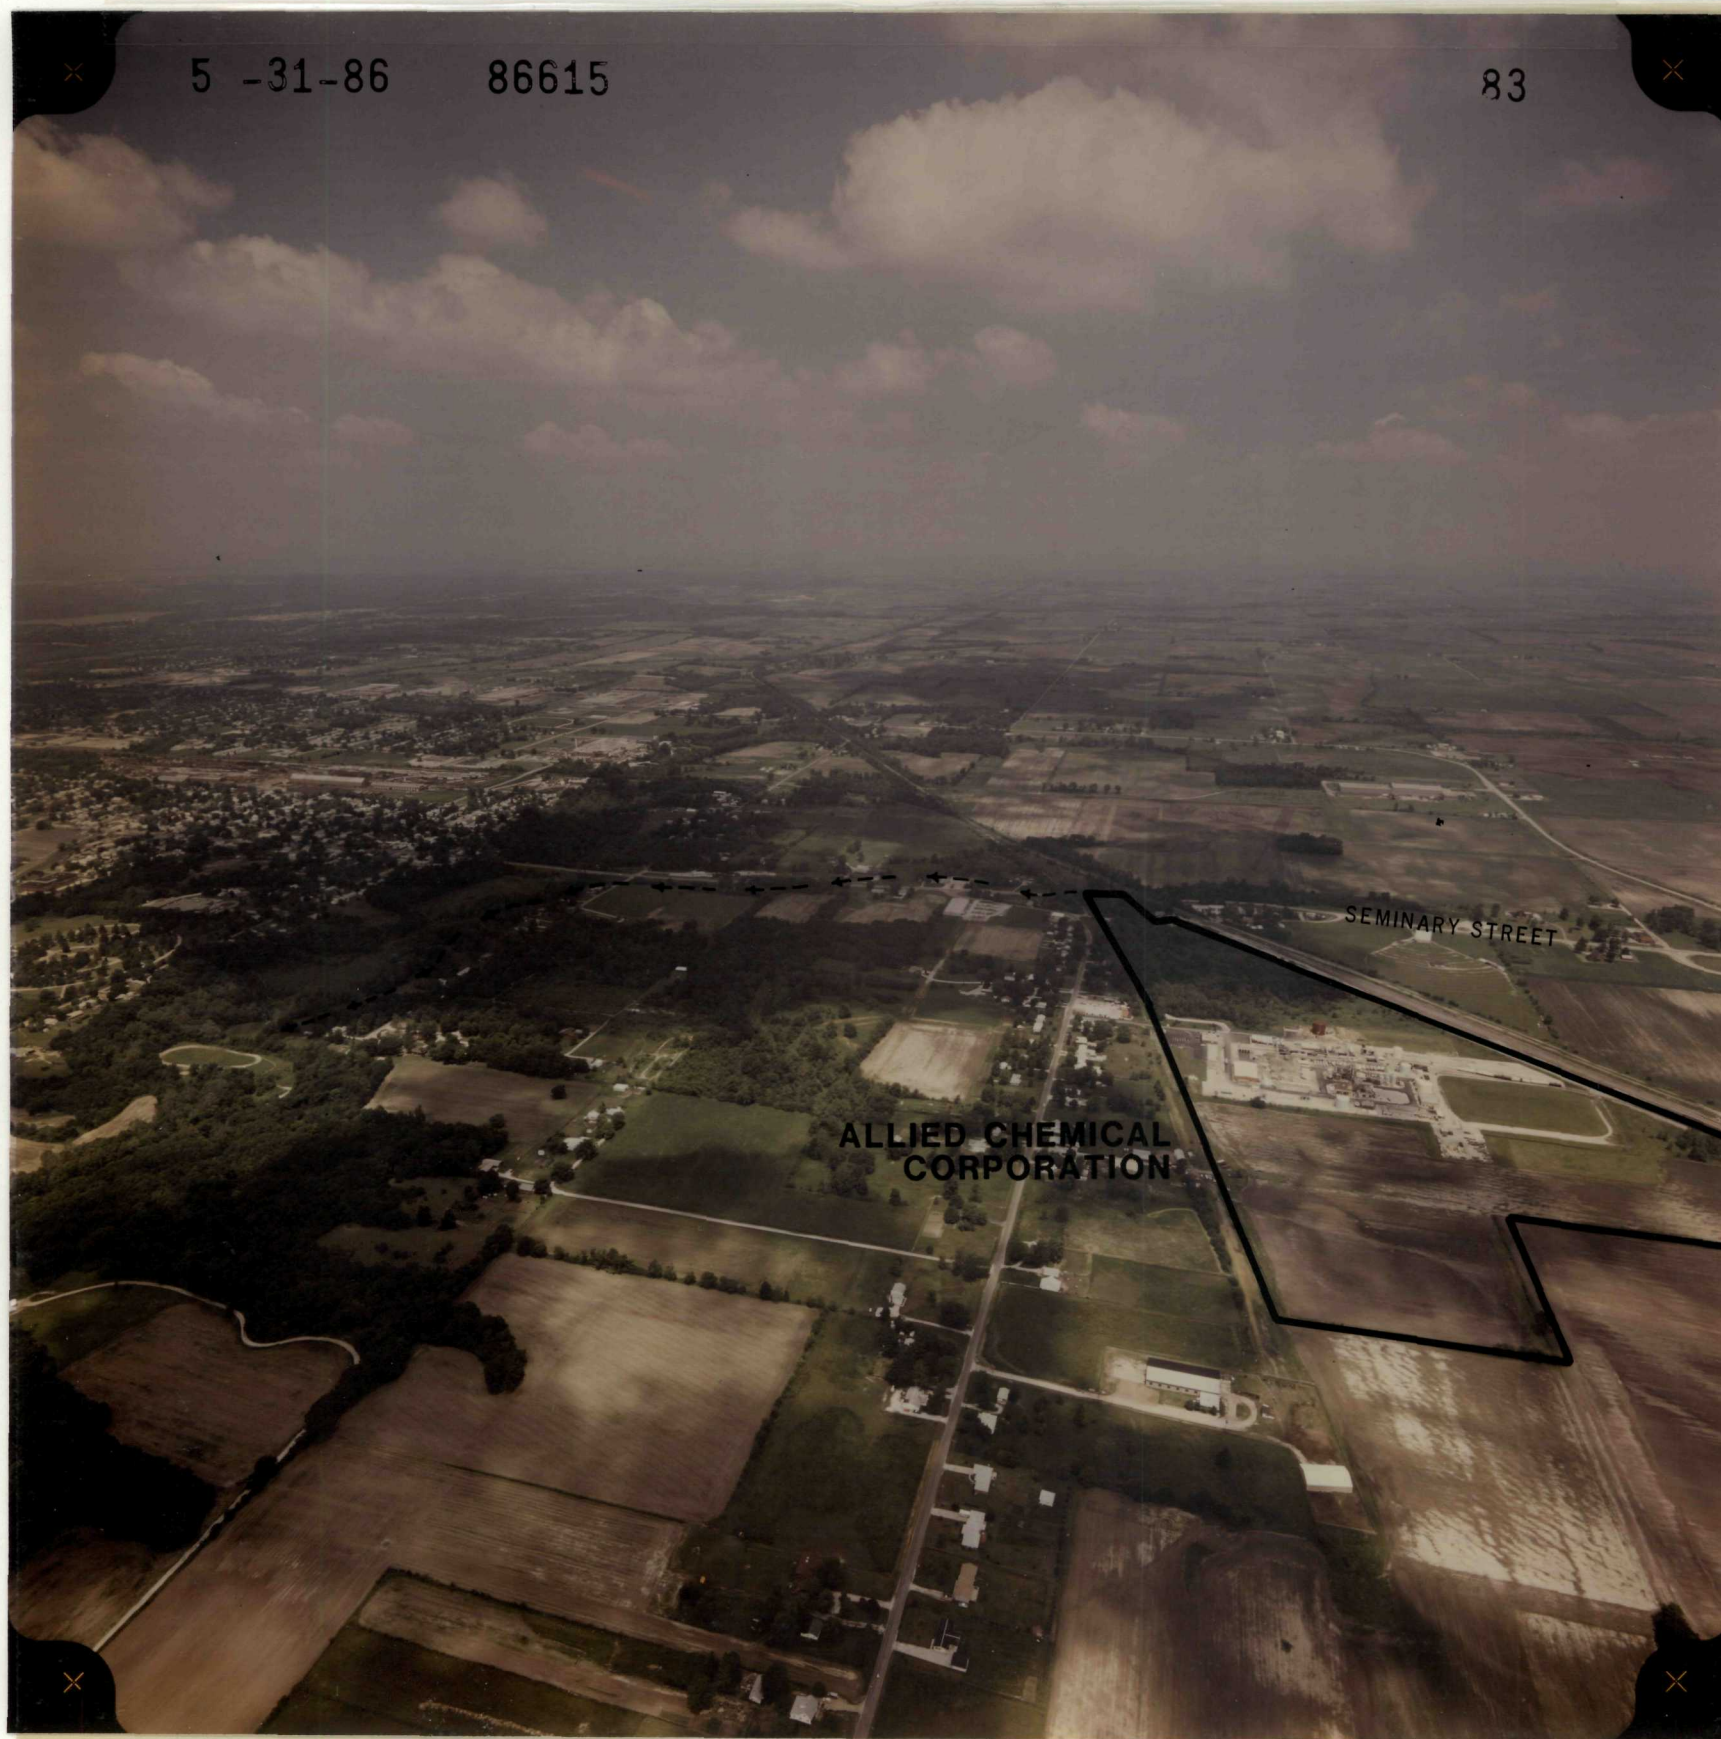
Figure 4. Allied Chemical Corporation, May 31, 1986. Oblique looking north.

Figure 4 shows an oblique view of the Allied Chemical Corporation and its environs.
